MB GPW G503 WWII Military Jeep Radiator Rebuild Restore WW2 Restoration

This article shows a step by step process of restoring your G503 WWII Jeep Radiator - By Lew Ladwig

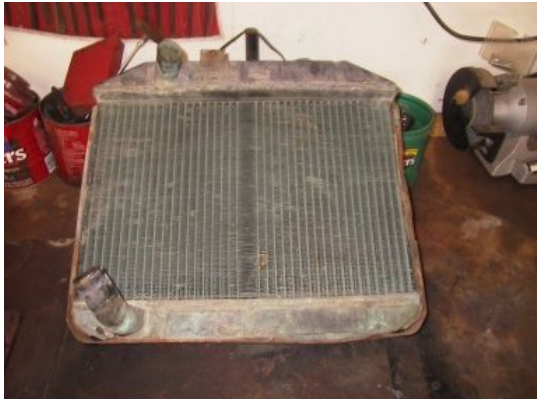
I found a good GPW radiator. Most of the thin fins are bent over but the tubes look to be OK. It has the correct 45 cut on the sides and the center missing tube. The tanks have several dents and the bottom tank is bulged out. This is probably due to freezing. My plan is: 1) Measure frame 2) remove frame 3) remove tanks 4) clean and rod 5) pound out tank dents etc. 6) straighten fins - remove tarnish 7) resolder 8) add shroud 9) add over flow tube 10) paint 11) zinc plate carriage bolts

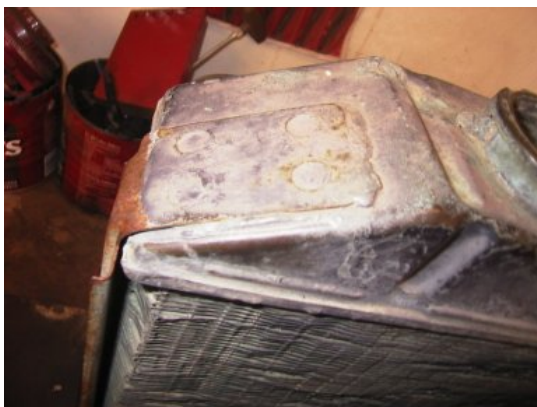
You can see where the frame is soldered to the top tank, there is also solder along the bottom and the lower corner tabs. Mine had broken the solder joint at the corners and most of the bottom.

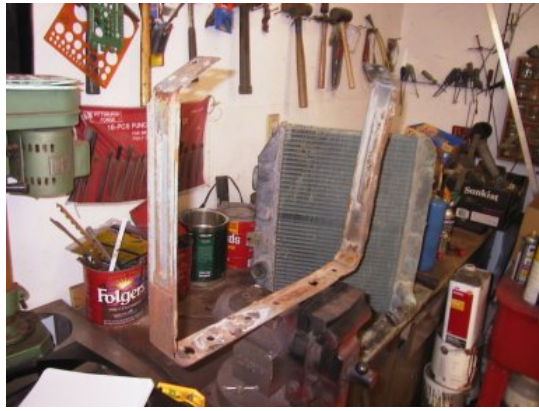
Here is the frame removed. Now I can sand blast it and bend it back straight. Many of these are rotted by the battery and could be repaired at this time.

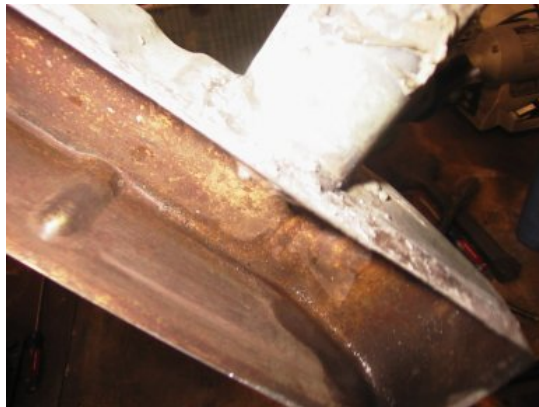
I have one spot that has a folded dent. I don't think I can pound it smooth but will try to reshape the area. I use body tools for this work. I removed several other small dents. The bottom was bulged out due to freezing so I pounded that back and reshaped the sides using a 2" square tubing as an anvil. Came out well.

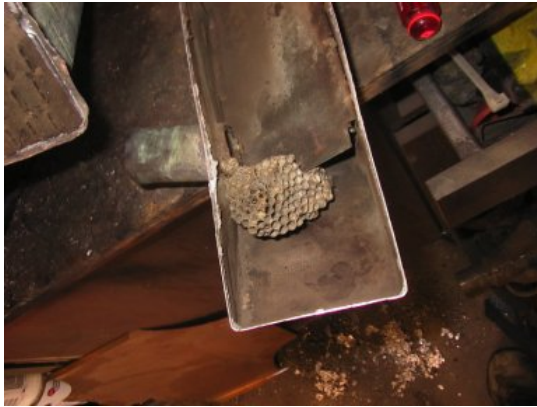
With the top off, look what we found, a wasp nest! Do you think a can of prestone flush would have removed that?

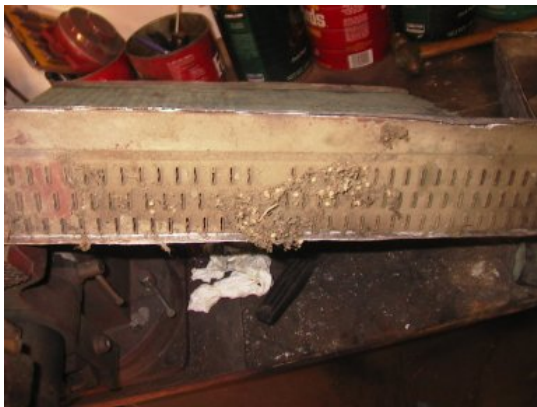
Lots of dirt and junk in the top:

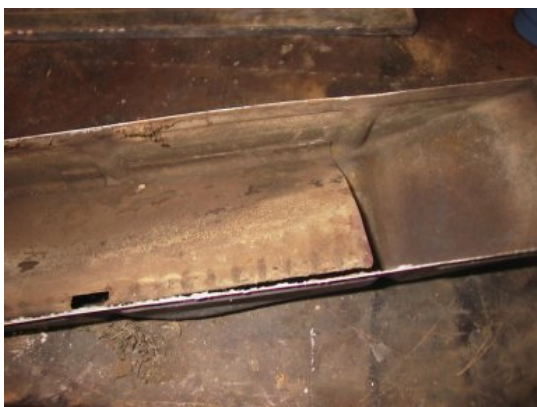
Baffle was loose in most parts:

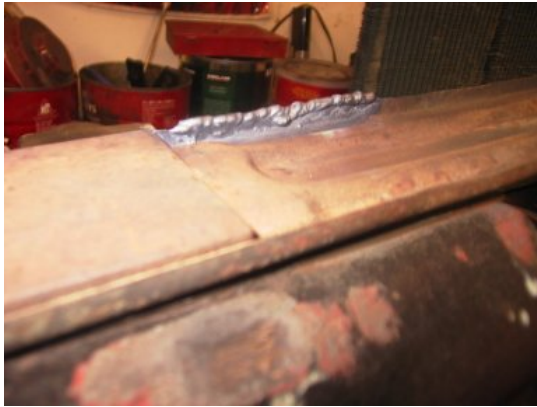
Here is the edge of the frame where acid rot from the battery and rubbing on something ruined the edge. About 1/8" to 1/16" was missing or very thin. The steel is too thin to mig weld so I O/A welded it.

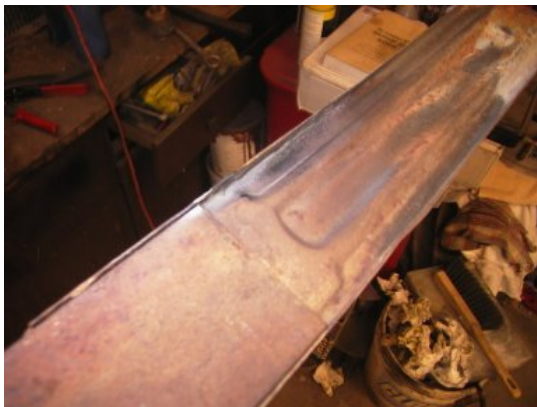
Then ground it smooth, look like new:

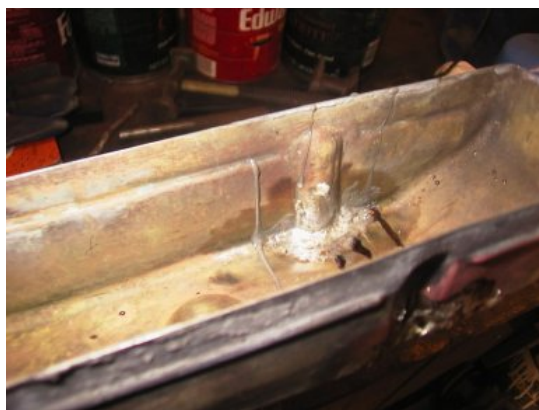
Next I fixed a very tiny crack by cleaning and soldering on the inside and out side. I did not back this one up as it was very small and I don't think it was cause by a load but rather when the bottom froze some.

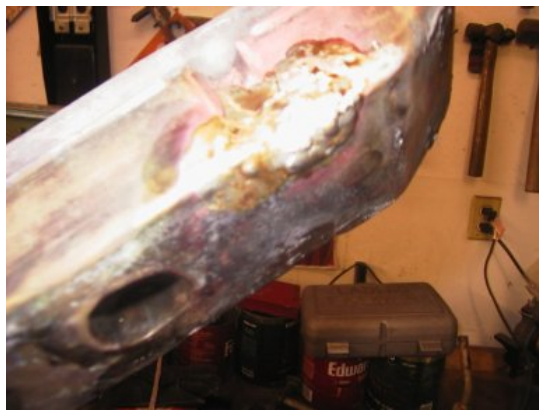
Next I needed to fix a real bad spot. This is where the brass was folded on it's self. I had one small spot where the brass was then layered and there was no way to fix it. So I pounded it all smooth and put a layer of solder over it all:

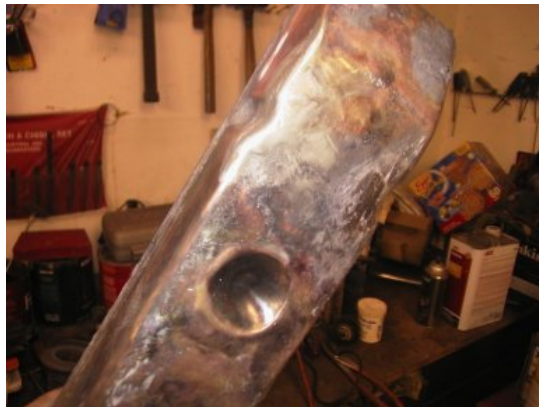
Since the area was where the "groove" in the side on the tank was, I had to shape things back to look right. I think it came out fine. next step will be to fit the tanks nice and tight and polish the brass bright before I solder it back up. Since the brass is soft, I can touch up the shape real easy. A good tight fit is improtant just like doing plumbing. Once it fits just right I'll tin it with a my tinning flux and then solder it all back up

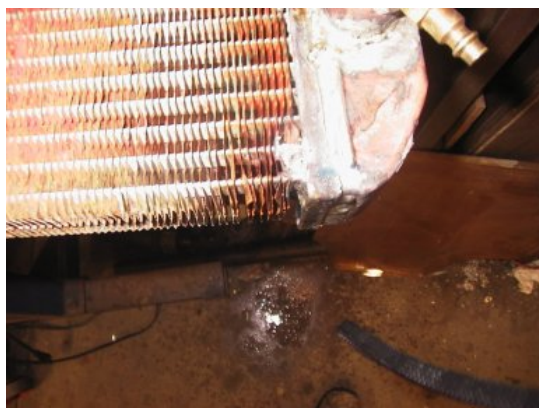
Then soldered it up. I could not get the lower fin back in place. I suppose if I worked on it some more I could but I would rather be sure it does not leak.
