MB GPW G503 WWII Military Jeep Radiator Rebuild Restore WW2 Restoration

This article shows a step by step process of restoring your G503 WWII Jeep Radiator - By Lew Ladwig

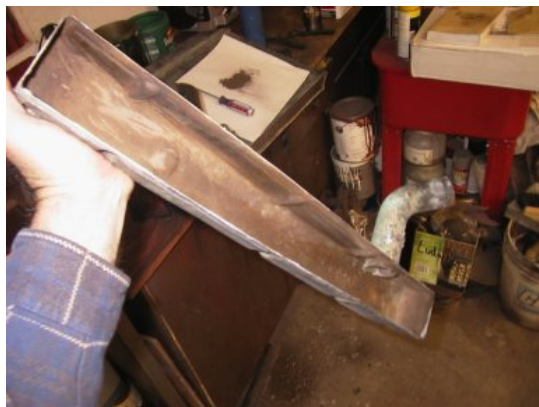
Here I am sweating the solder from the lower tank seam. Let gravity do much of the work. As you heat things up the two parts tend to separate with the heat. Be patient. I used a putty knife to scrape hot solder out of the joint. Worked for about 20min but did not have it apart yet. Another 10min should do it. The last radiator I did this on it came apart in about 20min or so. Just look for areas that are still soldered. Heat them up and work as much solder out of the joint as you can and wiggle the joint as it cools so it does not rejoin.

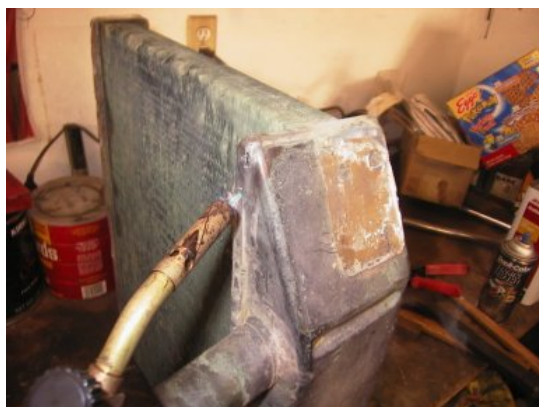
I have one spot that has a folded dent. I don't think I can pound it smooth but will try to reshape the area. I use body tools for this work. I removed several other small dents. The bottom was bulged out due to freezing so I pounded that back and reshaped the sides using a 2" square tubing as an anvil. Came out well.

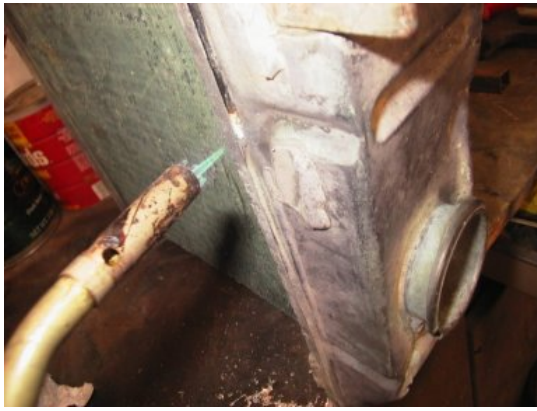
Worked on removing the top tank. It took about 15 min with the help of my oldest son. As you heat the seams the solder bubbles out. Set up so it runs out of the seam.

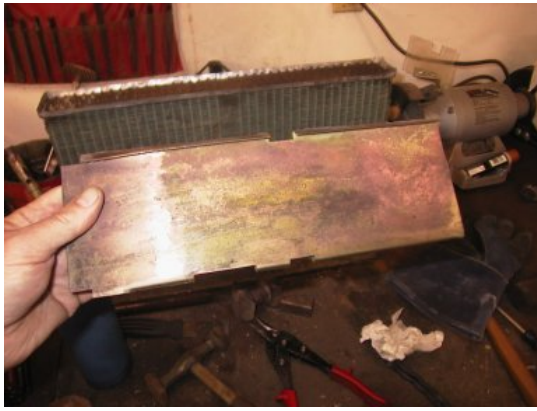
Baffle was loose in most parts:

Baffle is removed. I tried the muratic acid again as today was a warm one and the acid was much warmer. It does work but I need a better container so I can fit the big parts in.

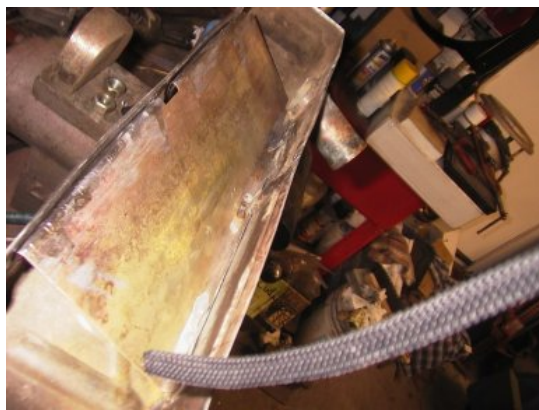
Next I needed to fix a real bad spot. This is where the brass was folded on it's self. I had one small spot where the brass was then layered and there was no way to fix it. So I pounded it all smooth and put a layer of solder over it all:

Since the area was where the "groove" in the side on the tank was, I had to shape things back to look right. I think it came out fine. next step will be to fit the tanks nice and tight and polish the brass bright before I solder it back up. Since the brass is soft, I can touch up the shape real easy. A good tight fit is improtant just like doing plumbing. Once it fits just right I'll tin it with a my tinning flux and then solder it all back up

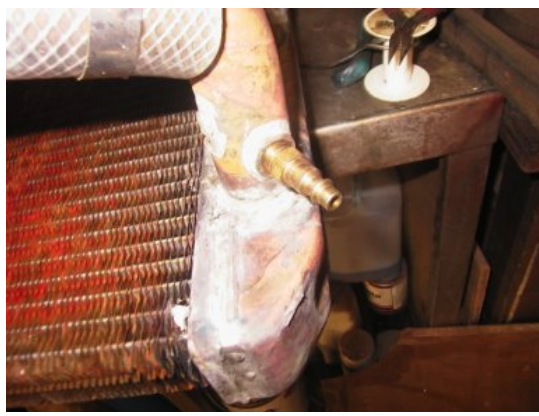
I set up my pressure testing method. I installed a hose over each pipe with a cap on the ends. I then put a standard air chuck fitting in the petcock hole. Installed a cap on the fill port. Hooked it up to my air compressor and charged it up until the air started leaking out the pressure cap. This was about 7 lbs.. I then checked for leaks with soapy water. I could have used a tub with water but did not want to do that just yet.
